Order from: **C A Briggs Company**

# Application Notes

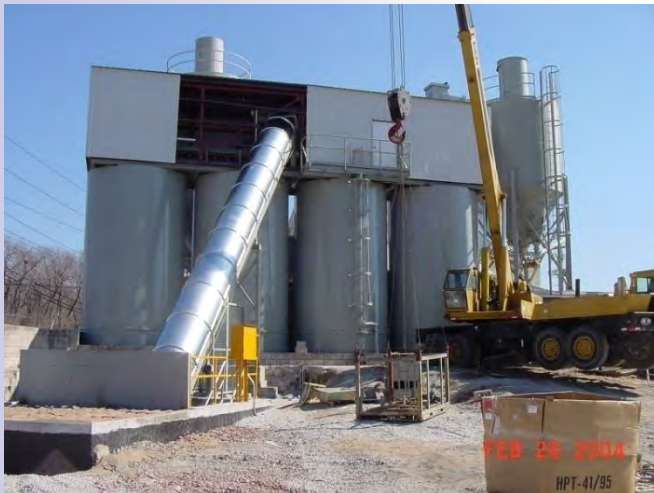
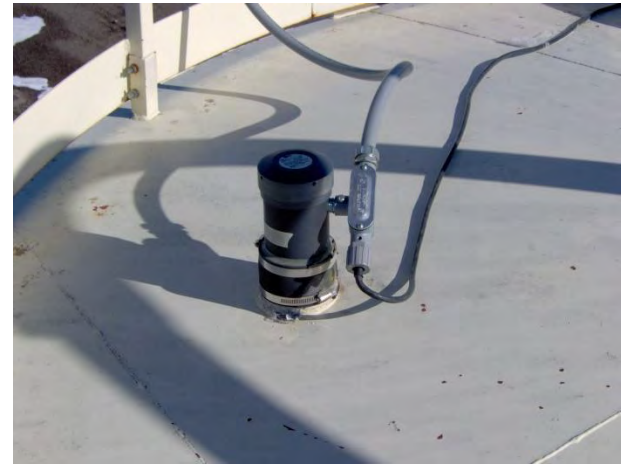
Application Problem: Radar unit has to have very narrow radiation beam to avoid false echoes from ship's body

Application History: Problems with false echoes.

Solution:  
ABM300-240R6C2-SSHR5-EXP

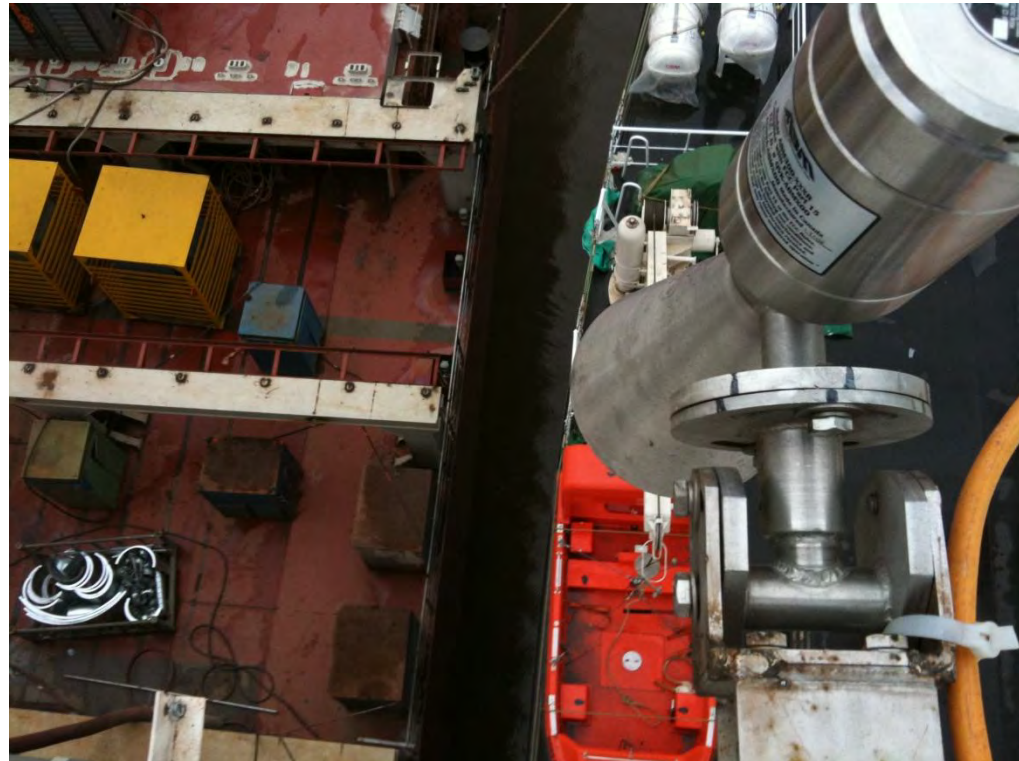
Application Problem: Heavy powder coal dust on belt conveyer, the sensor has to have very fast response

Application History: All used non-contact sensors had very slow response and were effected by the powder coal dust

Solution: ABM ultrasonic level device ABM300-148ULC2-PVPVC solved all the problems

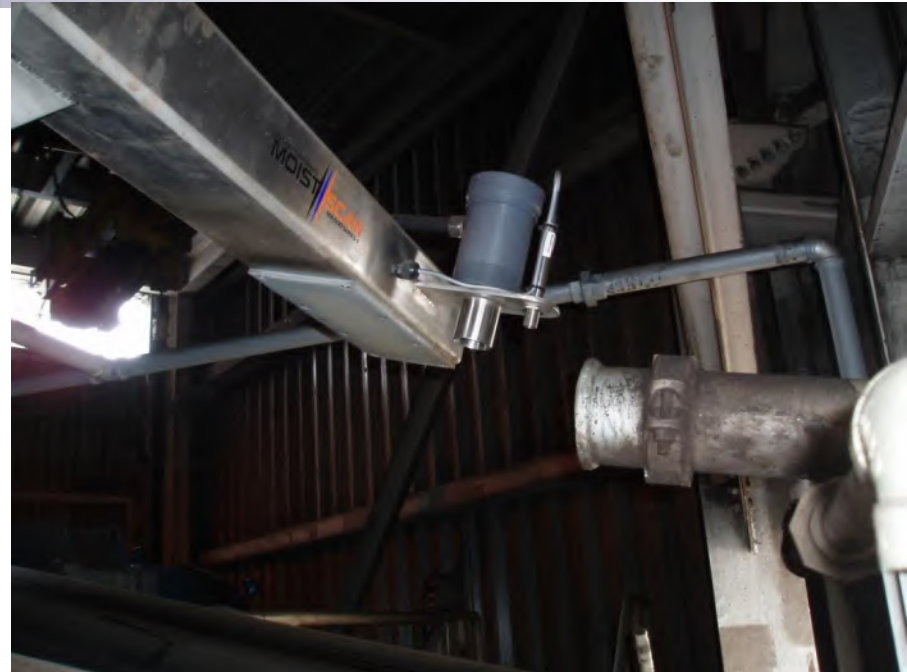
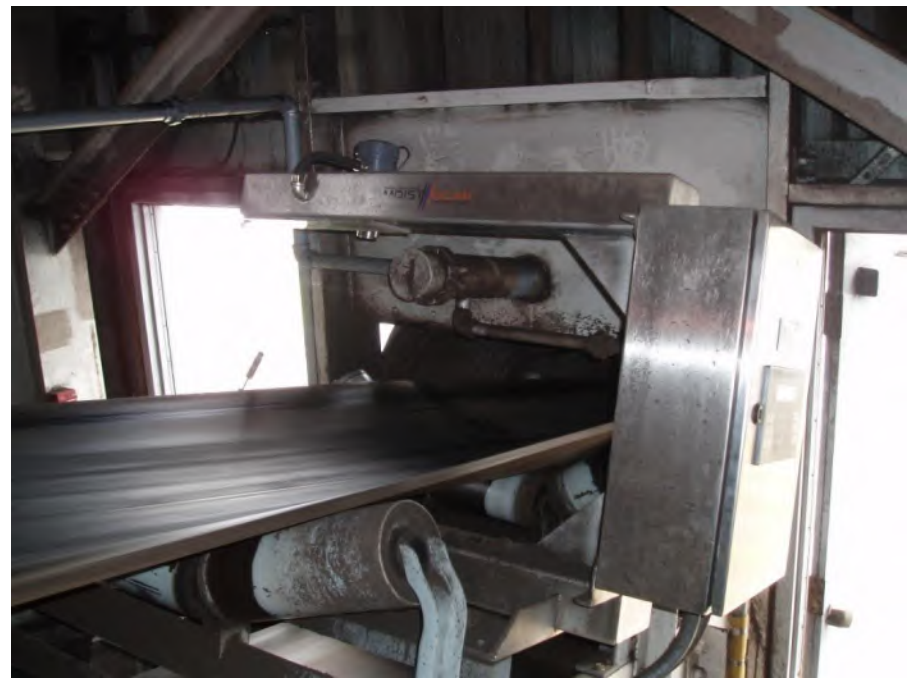
Application Problem: Sand with heavy dust on belt conveyer.

Application History: There was no device working reliably.

Solution: ABM ultrasonic device  
ABM300-148ULC2-PVPVC solved all problems

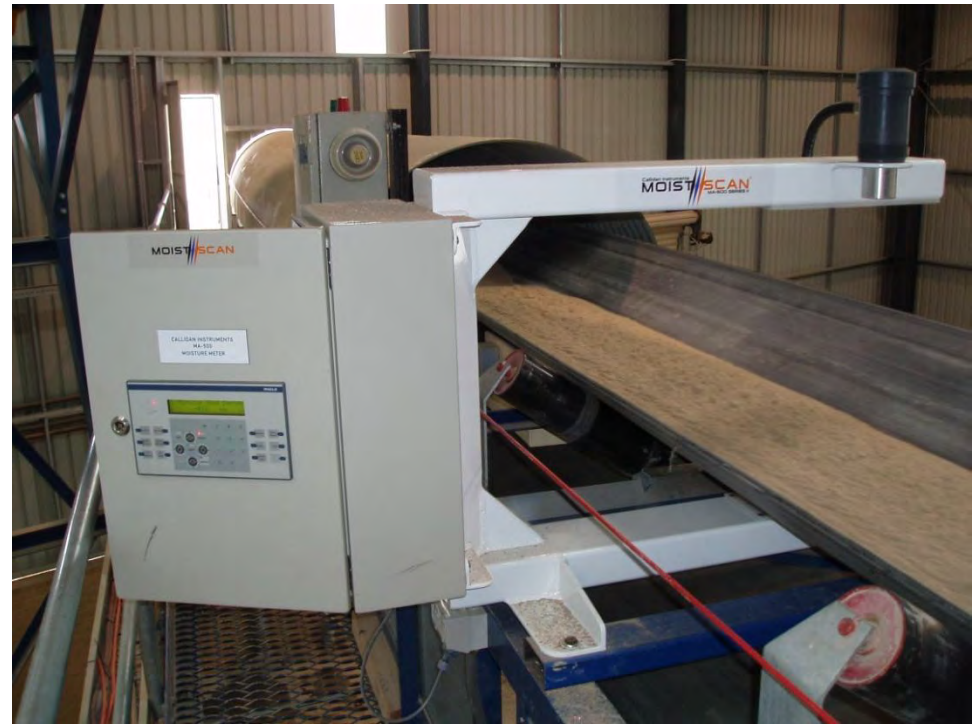
Application Problem: response, accuracy and resolution of competitors sensors was not great. Also the competitors sensors gave false echo's.

Application History: “On a vertical disc filter, the material being filtered is nickel concentrate. We measure the cake thickness to compensate for load to give a load independent moisture result.”

Solution: ABM300-148ULC2-PVPVC

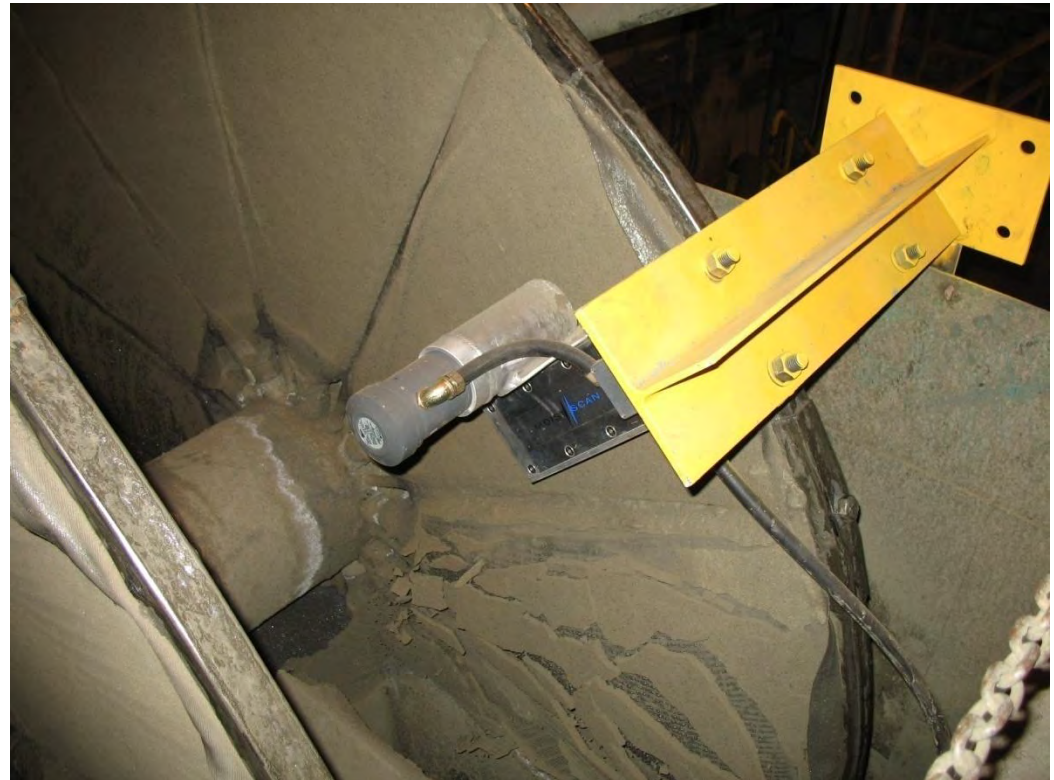
Application Problem:  
Hot 400F asphalt plus  
horizontal shape tanks

Application History:  
Problems with tank shape and  
temperature

Solution:  
They use our high temperature  
EX-radar on hot asphalt, the  
temperature is around 400F,  
metal stilling wells from top to  
bottom where installed, ID of  
pipes 3".

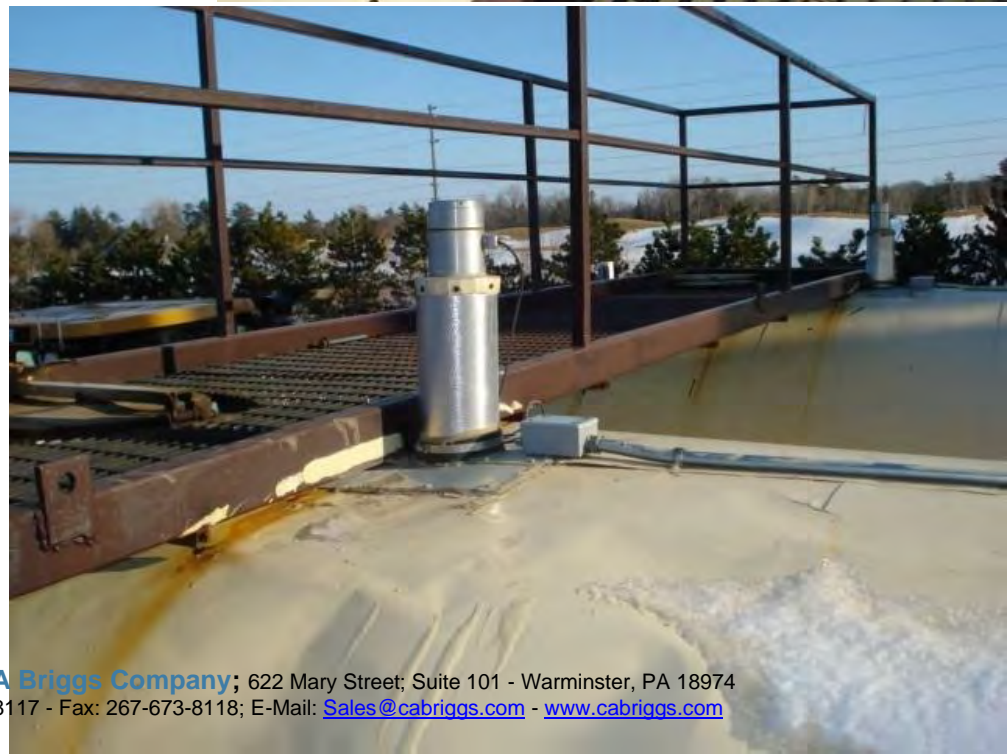
Very corrosive material,  
foaming, ammonia and CO<sub>2</sub>

They were using TDR with metal rods that would have a buildup of material and would also fall off. Customer didn't want to have to clean the rods all the time and fish out the rods from the bottom of the tank.

Our high temp radar solved all problems.

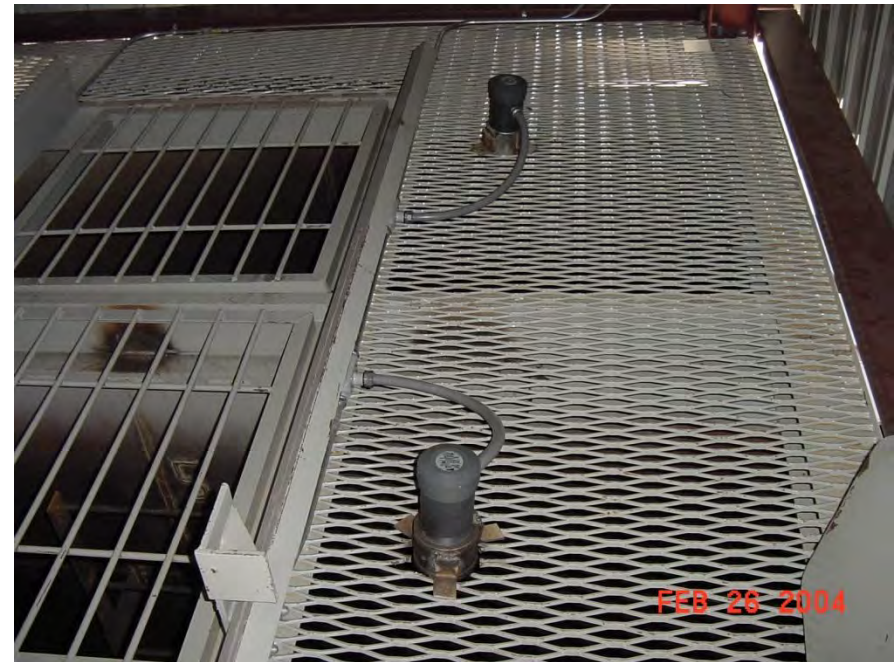
Application Problems: 30ft Rectangular shape tanks with sand, material has a steep angle of repose.

Application history: Due to a steep angle of repose contact and non-contact level devices gave false readings.

Solutions: ABM400-45UC4 ultrasonic level devices are used. They track the material level over the 30ft range. Ultrasonic transducer with uniform polar pattern and wide frequency bandwidth together with optimally matched transceiver and signal processing eliminate skip effect that is caused by solid materials with steep angle of repose.

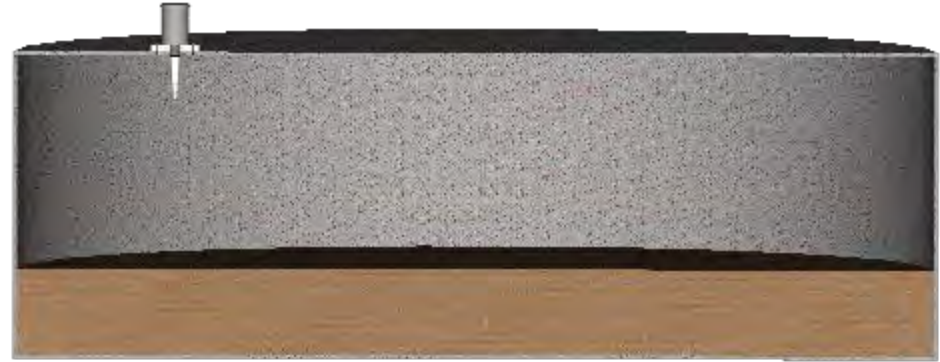
Application problems: Digester for sludge treatment. Inside is sludge mixed with water. The process generates methane that absorbs ultrasonic waves. The environment is explosive so equipment with EX (Class 1 Div 1) approvals is required.

Application History: These customers tried several ultrasonic level detectors that didn't work because of methane. Some radar units were also used, they had echo stability problems which gave false readings.

Solutions: ABM300-050RC2 with safety barrier is used. The reading is very stable for the full range of sludge level. The safety barrier caused supply voltage drop to 12Vdc. Even at 12Vdc the radar works great in this difficult application.

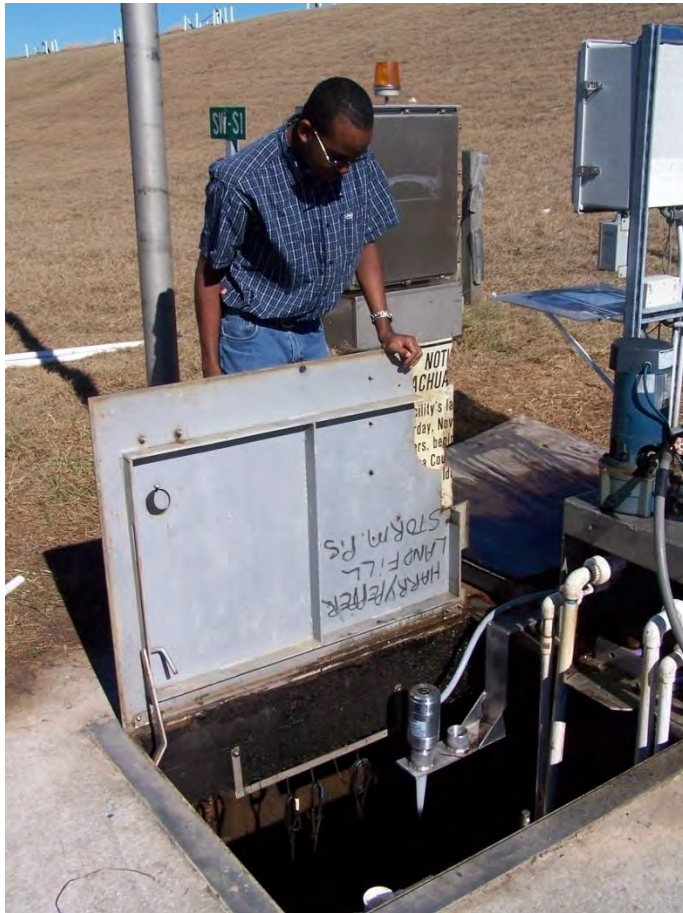
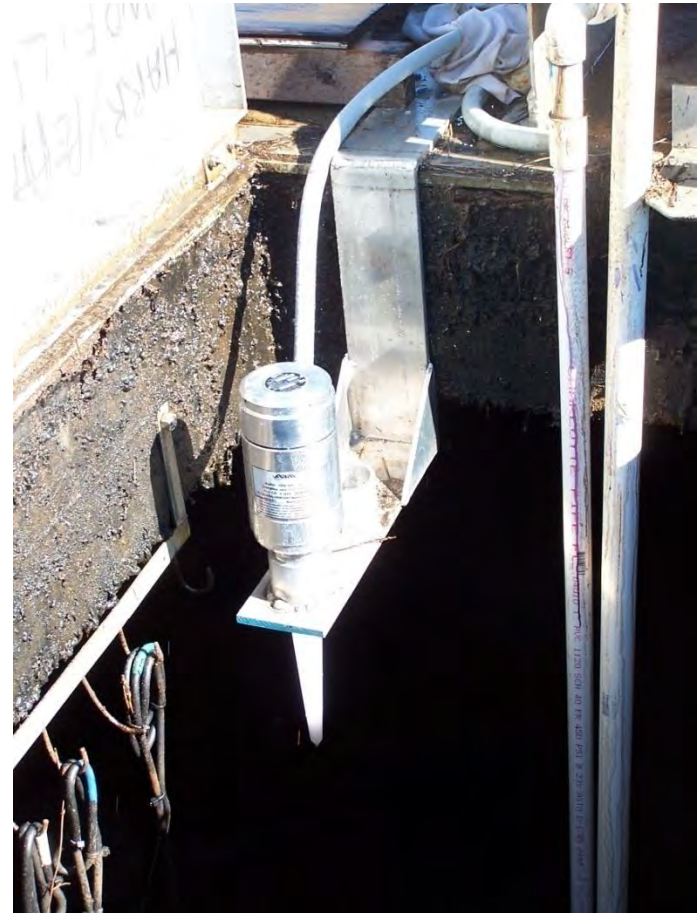
Application problems: to measure liquid level in a below ground (max depth 45 feet) landfill leachate sump (12-foot diameter, concrete and steel walls). This is contaminated water and atmosphere in the sump is toxic, corrosive landfill gas, 50% methane, 50% carbon dioxide, assume saturated humidity conditions, frequent hose downs of sensor and possible impingement on sensor body by storm water.

Application history: Challenging environment, submersible pressure sensors have all failed.

Solutions: 50Ft EX approved ABM radar solved the problem.

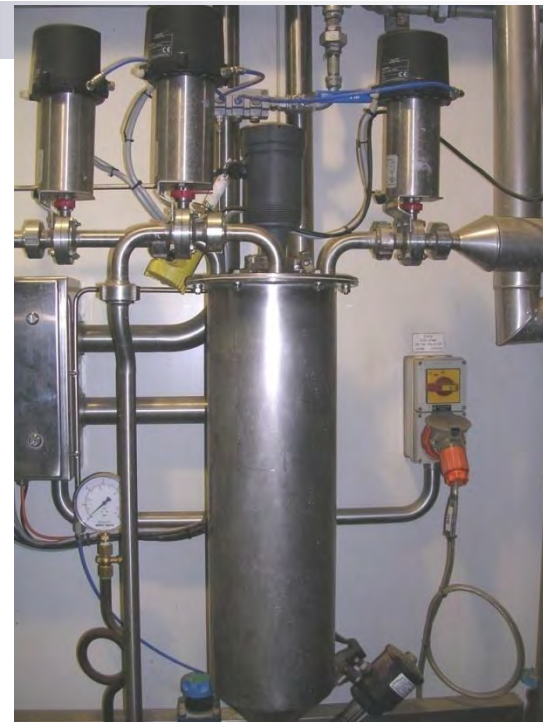
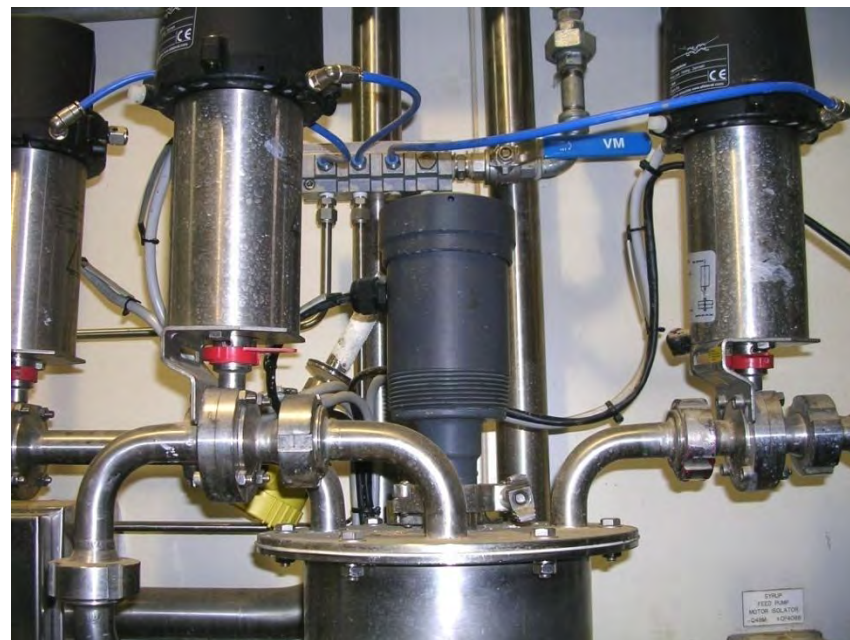
Installation is too close to the edge of the tank.

Fluid: waste acid which is very corrosive substance.

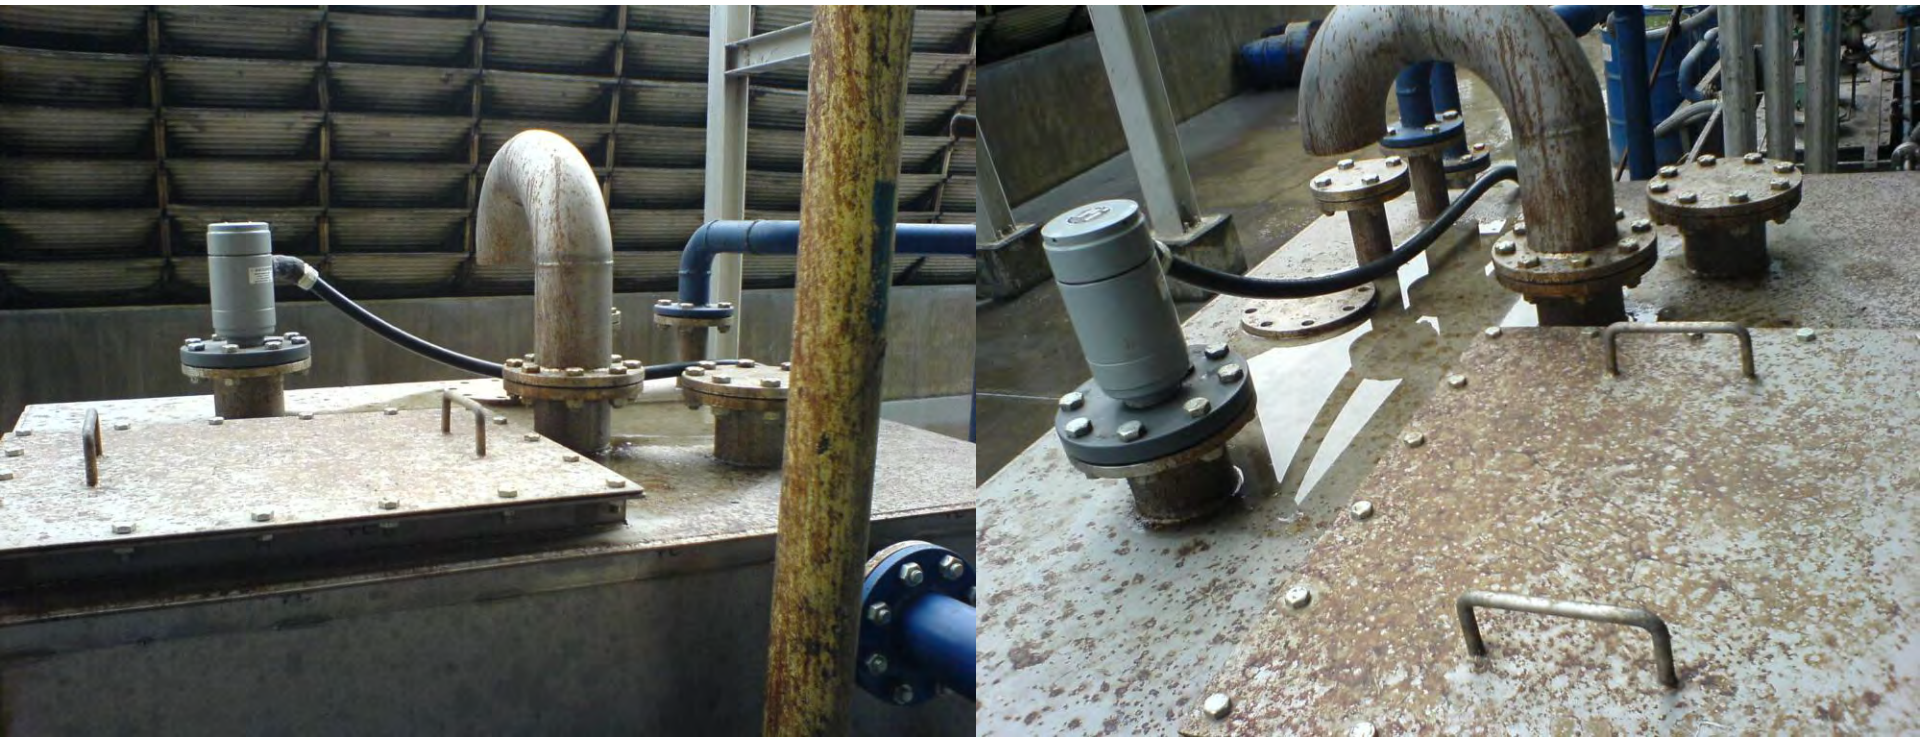
Narrow Tanks, very close mounting of radar to the wall (it is about 2 inch)

Fluid: Waste water

Customer tried various brands of contact device on this application. However, there was a false reading on measurement level due to interruption by the moisture & vapor from the waste water.

Solutions: ABM400- 050R6C2-ALAPP non-contact radar eliminates influence of the moisture and vapor .

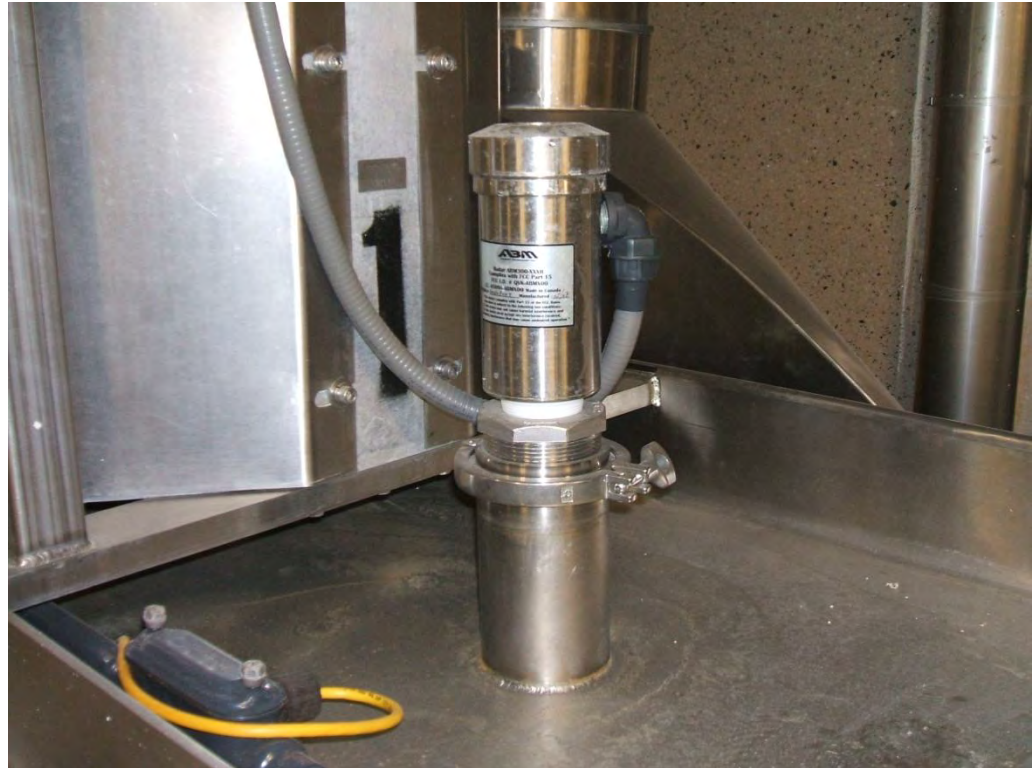
**Application Problem:** Very fast response pulse radar with at least 10 updates per second to control the lifting of ships bodies.

**Solution:** The solution to this problem is ABM pulse radar with fast protocol. Its response is 15 to 30 echoes per second

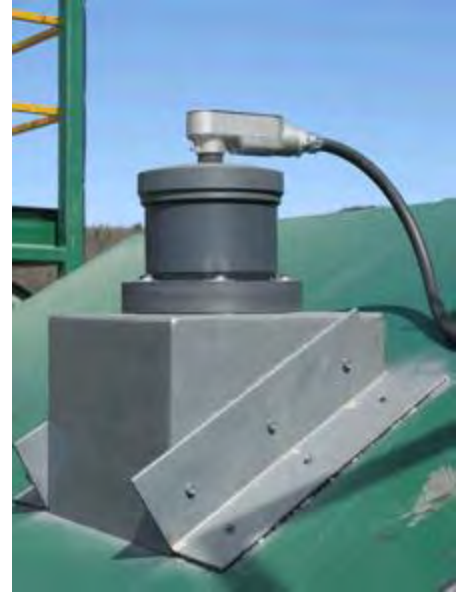
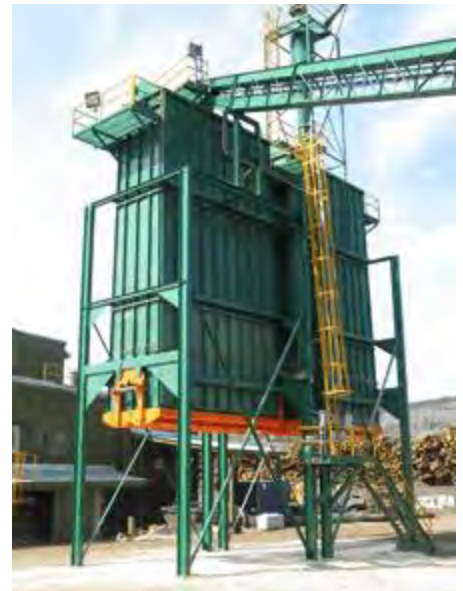
Fast response, low power consumption, close to wall mounting, self cleaning.

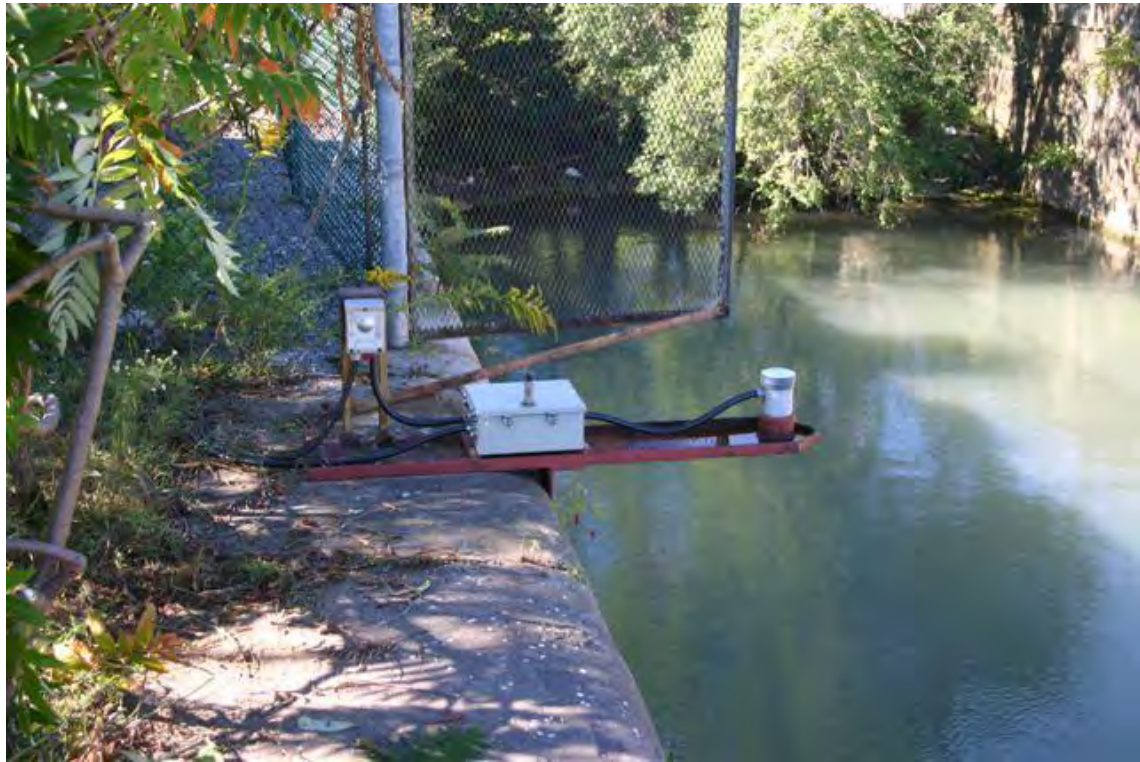
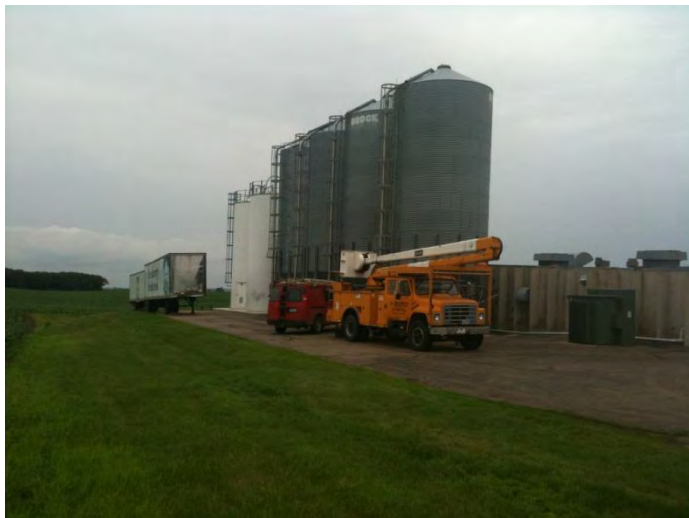
**Application Problem:** Plastic pellets, sensor mounting very close to corrugated tanks wall. Very low power consumption and a fast start-up (a few seconds) for battery supply system.

**Application History:** Units from competitors offer no operation, false echo's from corrugated tanks wall, high power consumption and long start-up which is ni go for battery supply system.

**Solution:** ABM300-045ULC2-PVPVC-AIM3, fulfills all above requirements.

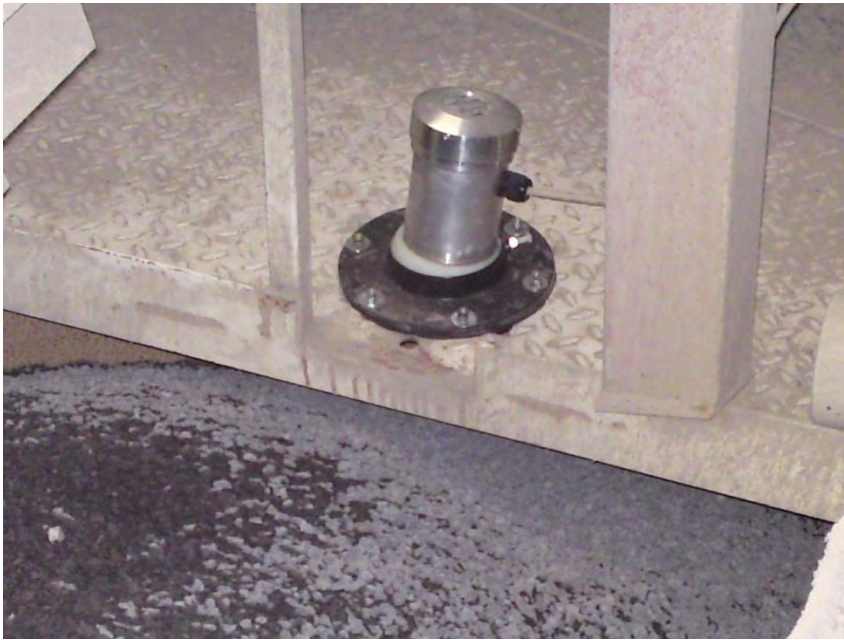
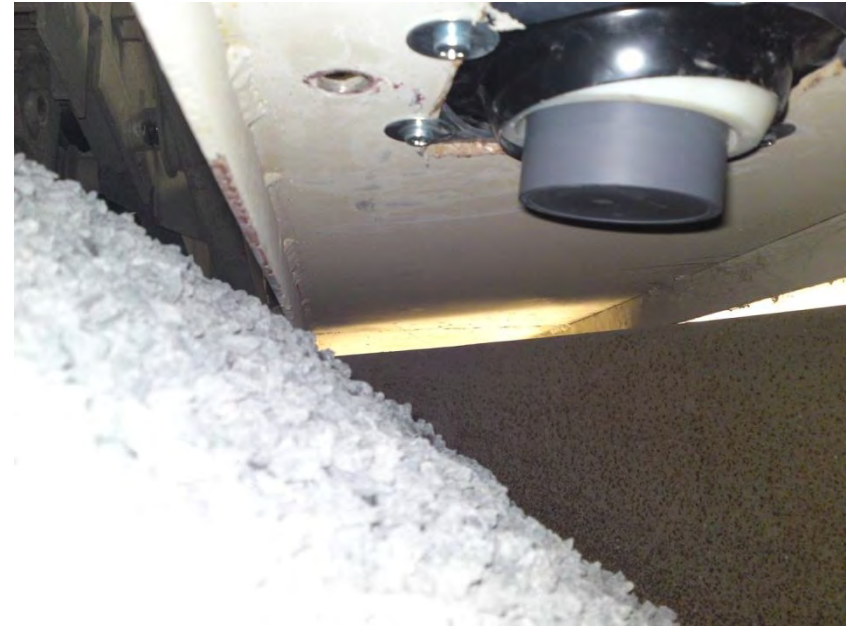
**Application Problem:** Plastic pellets with dust, very steep angle of repose.

**Application History:** Due to dust and steep angle of repose nothing worked before.

**Solution:** ABM300-045ULC4-PVPVC-AIM3 solves all the problems.

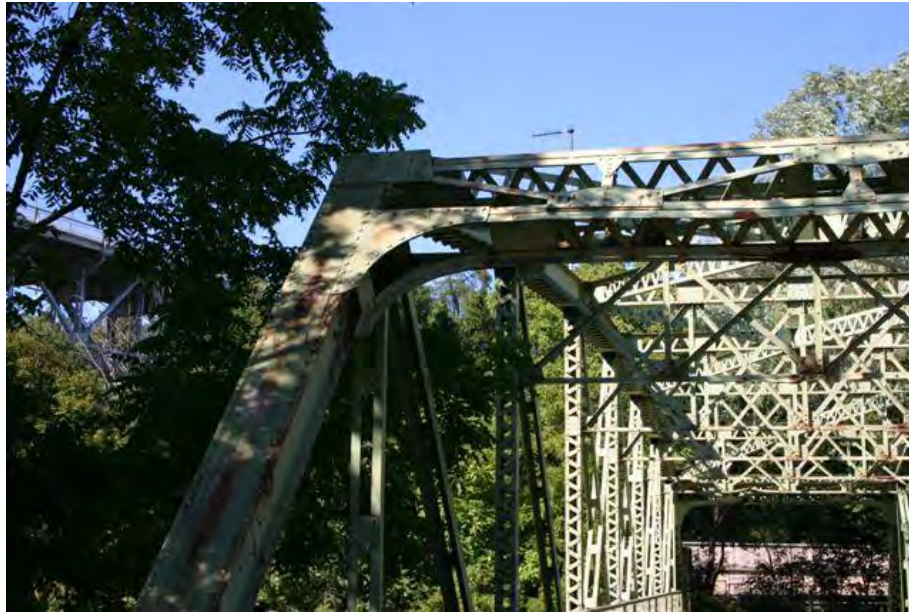
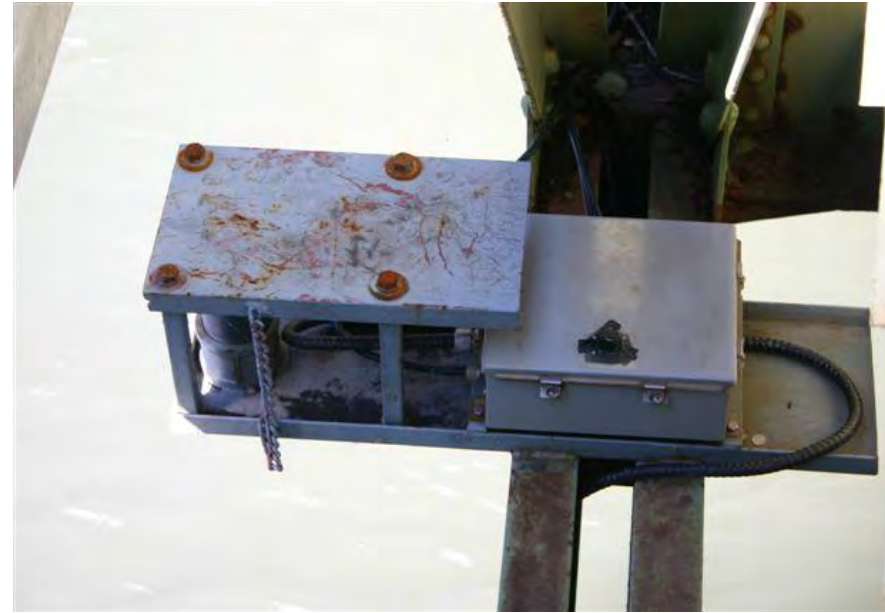
**Application Problem:** Extremely low power consumption, battery supply with RF transmitter of the current output 4mA to 20mA.

**Application History:** Anti-flooding system for river, no-system satisfied their needs.

**Solution:** ABM300-045ULC4-PVPVC

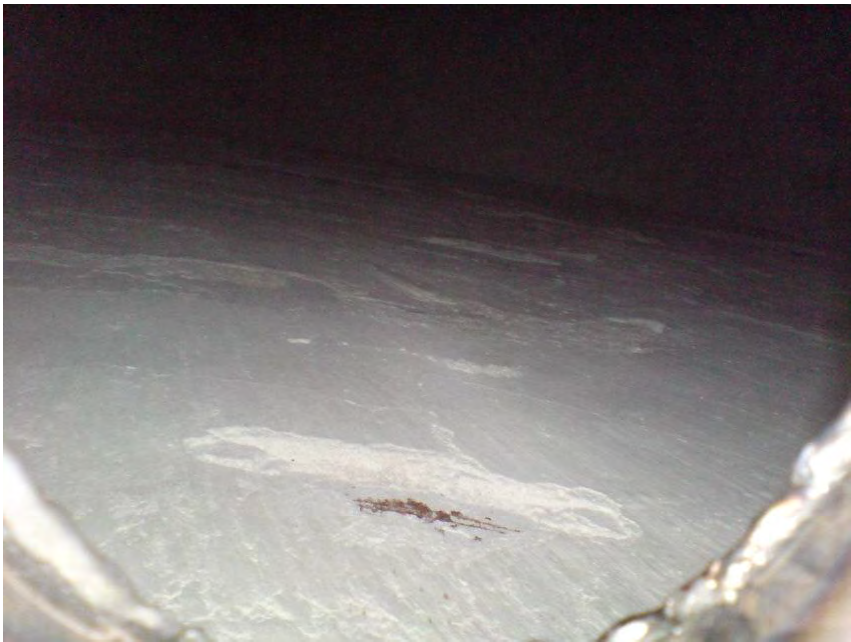
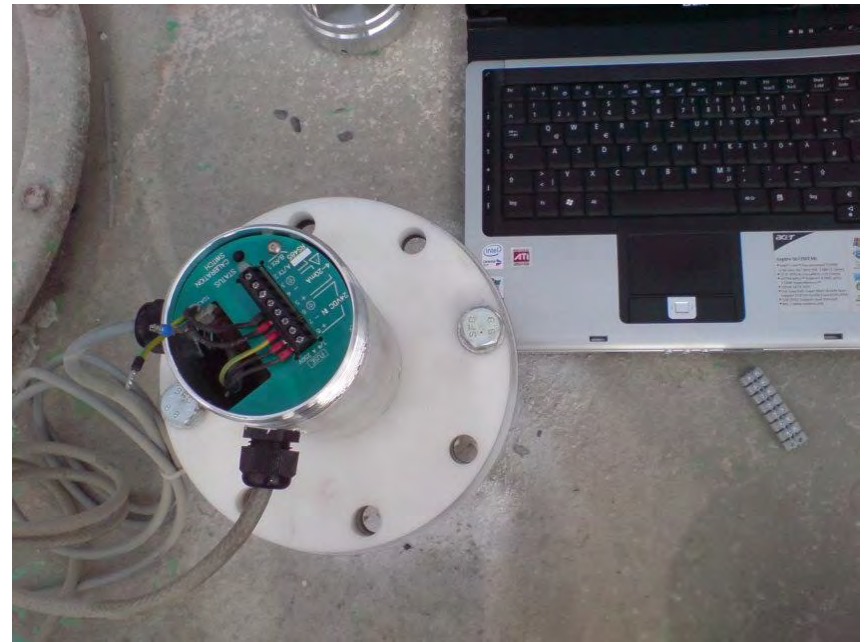
**Application Problem:** Chalk, dust, very low dielectric constant, close to wall

**Application History:** Nothing worked, the other brands units picked-up false echoes from tank's wall, they didn't work also during filling conditions.

**Solution:** ABM Ex-proof self adjusting radar with horn antenna solved all problems. Model number is: ABM300-100R6C4-ALHR6-EXP,

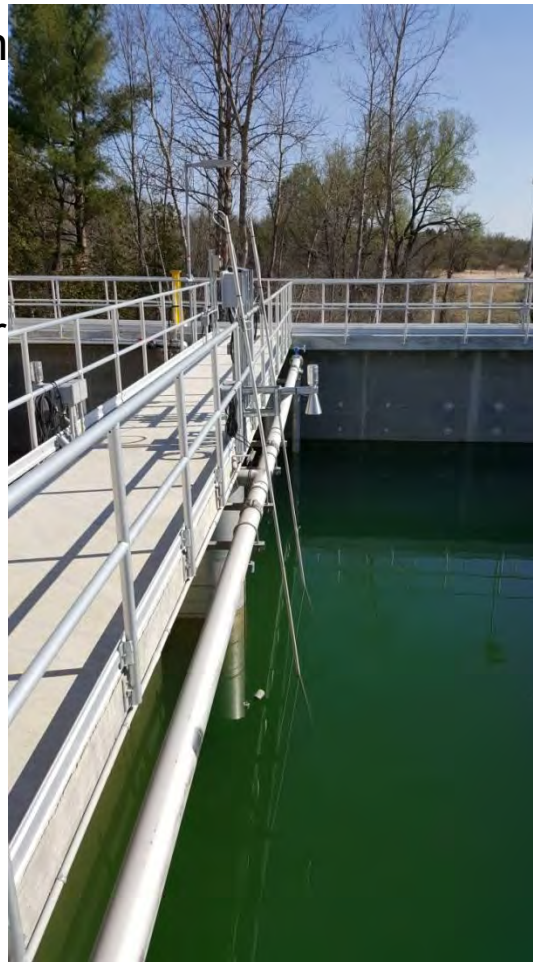
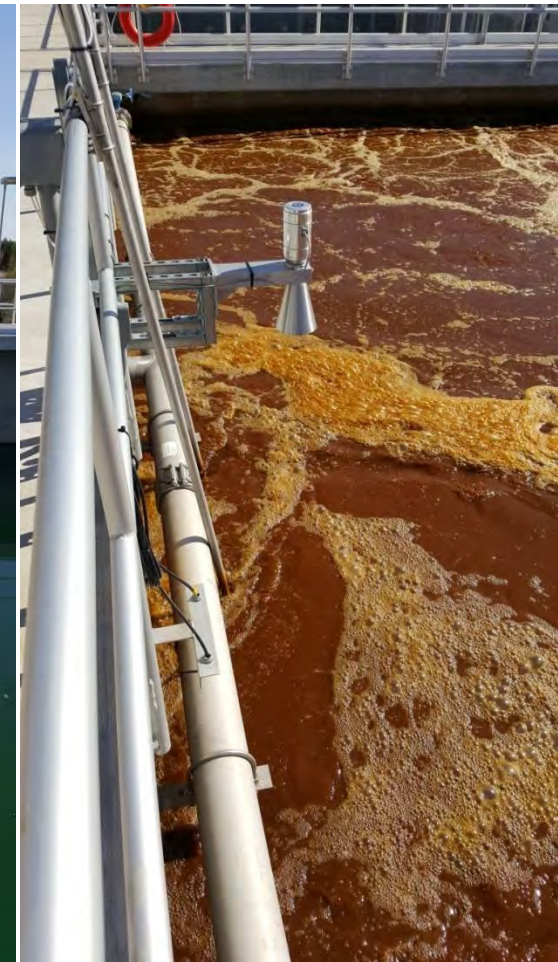
- **Application Problem**: Ice on liquid.
- **Application History**: No other brands were able to eliminate ice influence and measure liquid surface.
- **Customer Comments**: ABM radar is the only one that eliminates ice influence.
